Stability of Natural Slopes and Embankments Underlain By Weak Clays

Prof. Dr. Yousef M. Masannat

Creep displacement and progressive failure

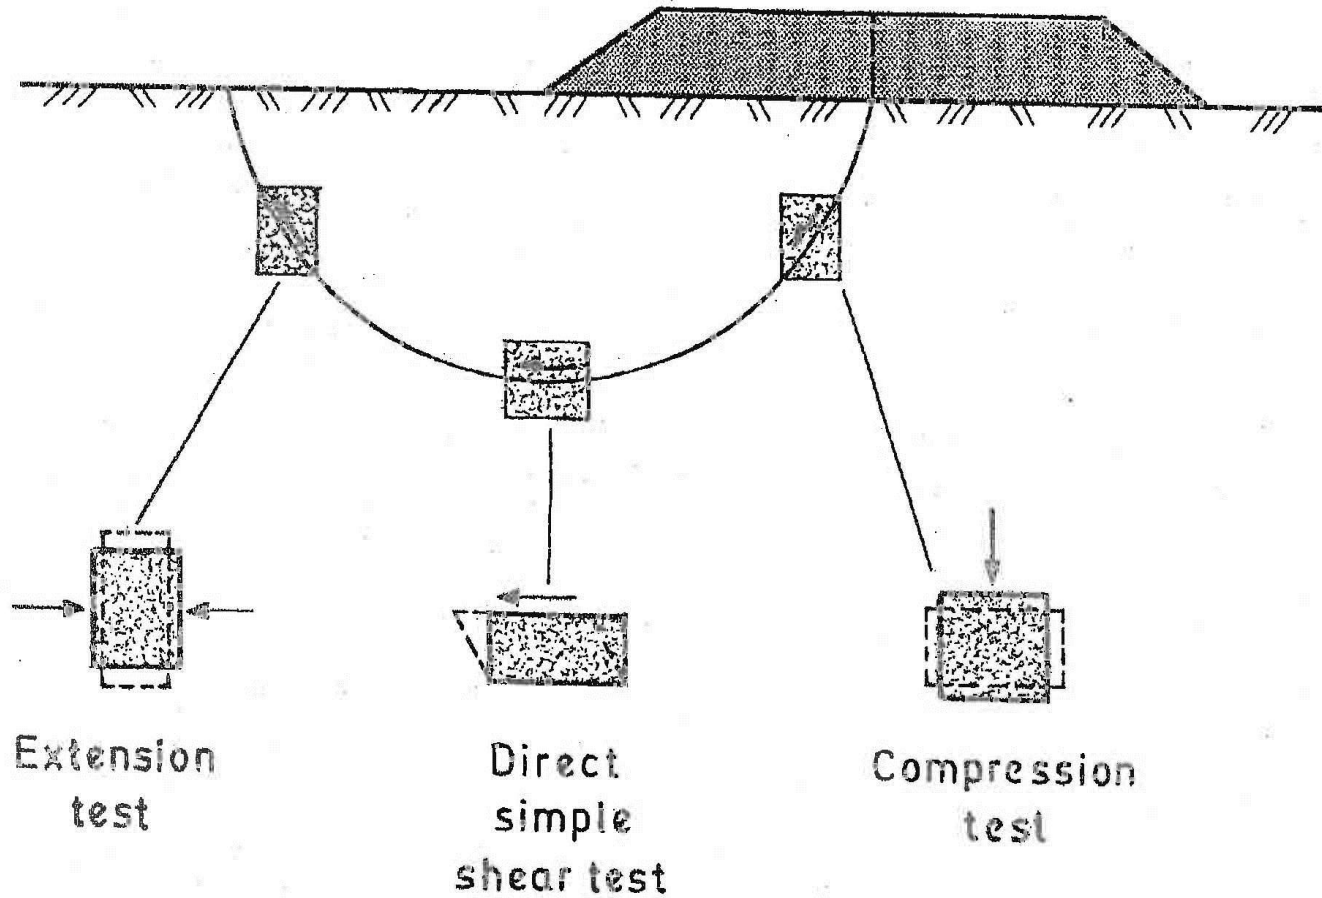
Fig. 1 Relevance of laboratory shear tests to shear strength in the field (Ref1).

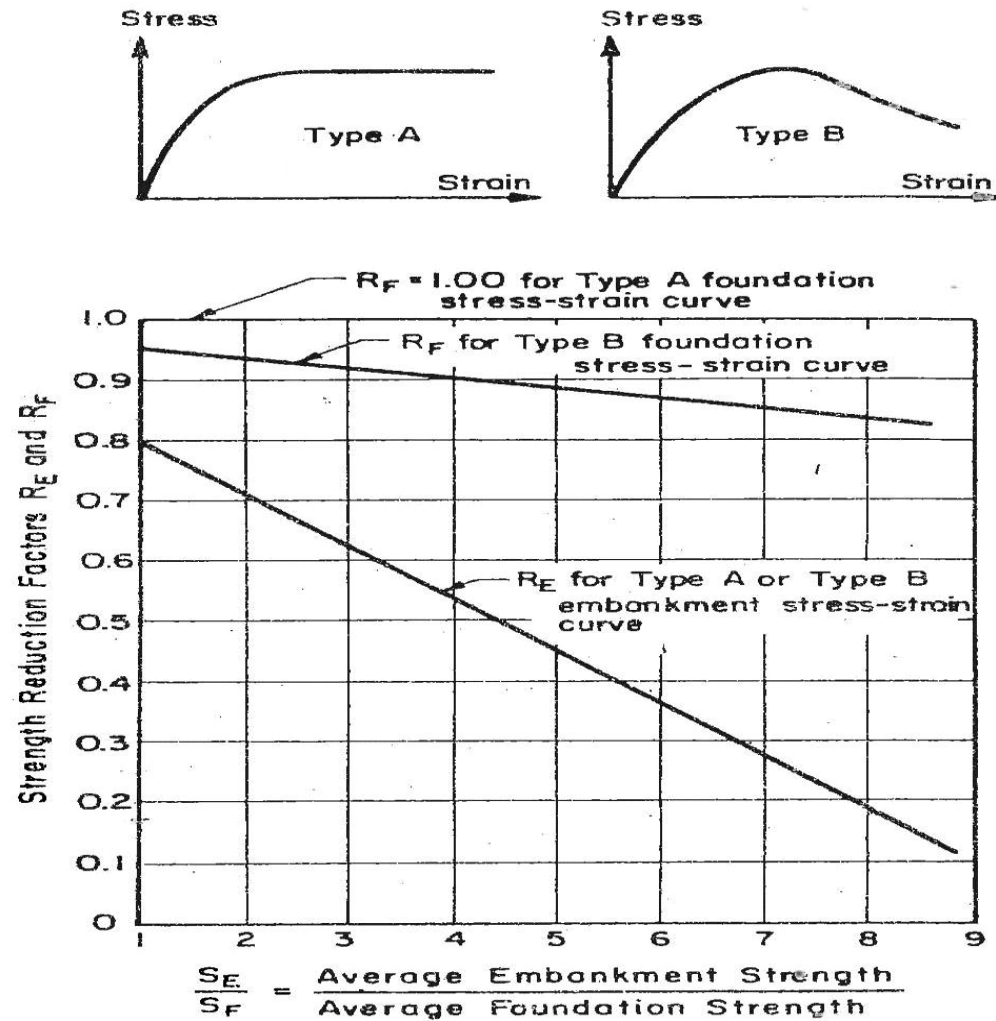
Fig. 2 CORRECTION FACTORS R_E AND R_F TO ACCOUNT FOR PROGRESSIVE FAILURE IN EMBANKMENTS ON SOFT CLAY FOUNDATIONS. (Ref.3)

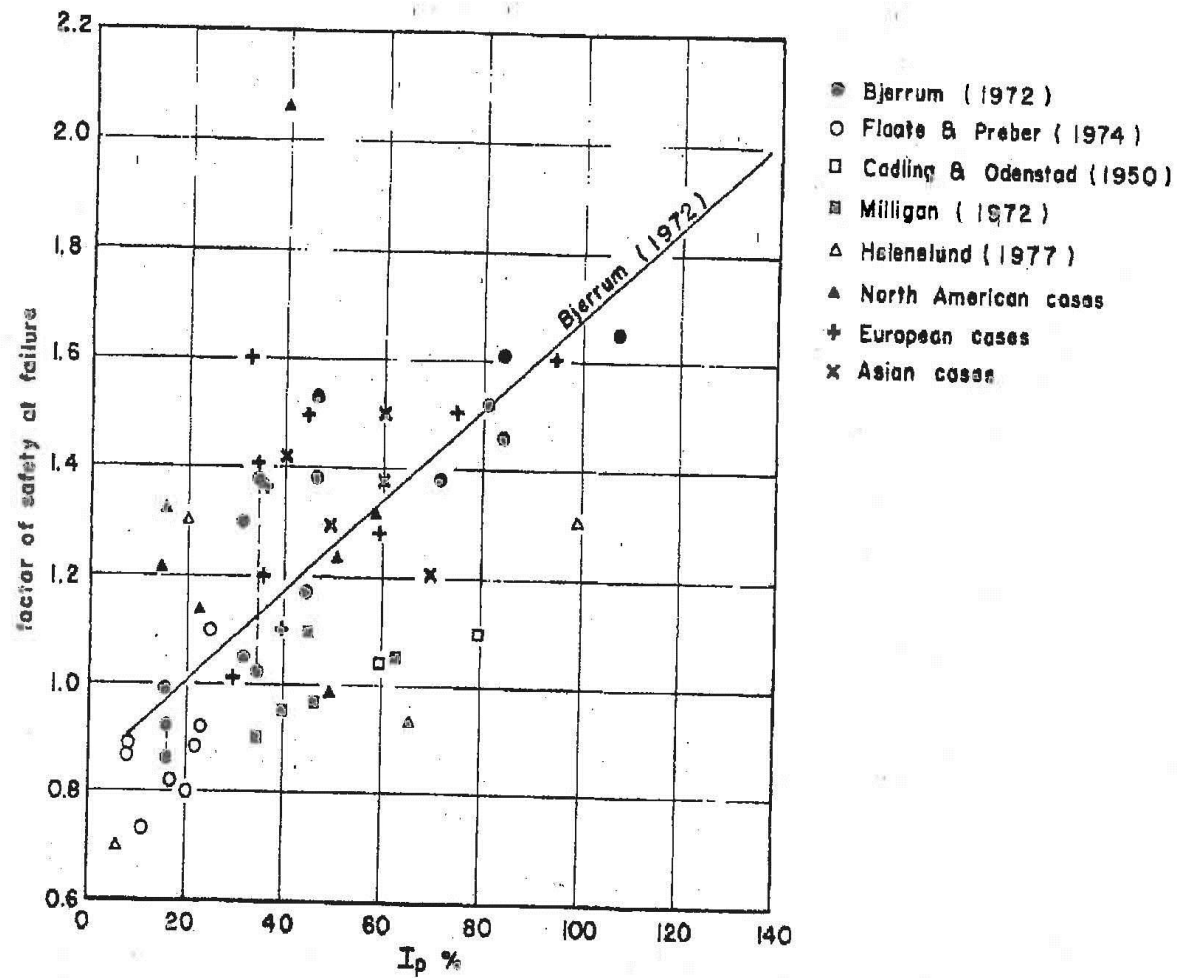
FIG. 3 Factors of safety at failure from all published case histories (as of 1979) (Ref 14).

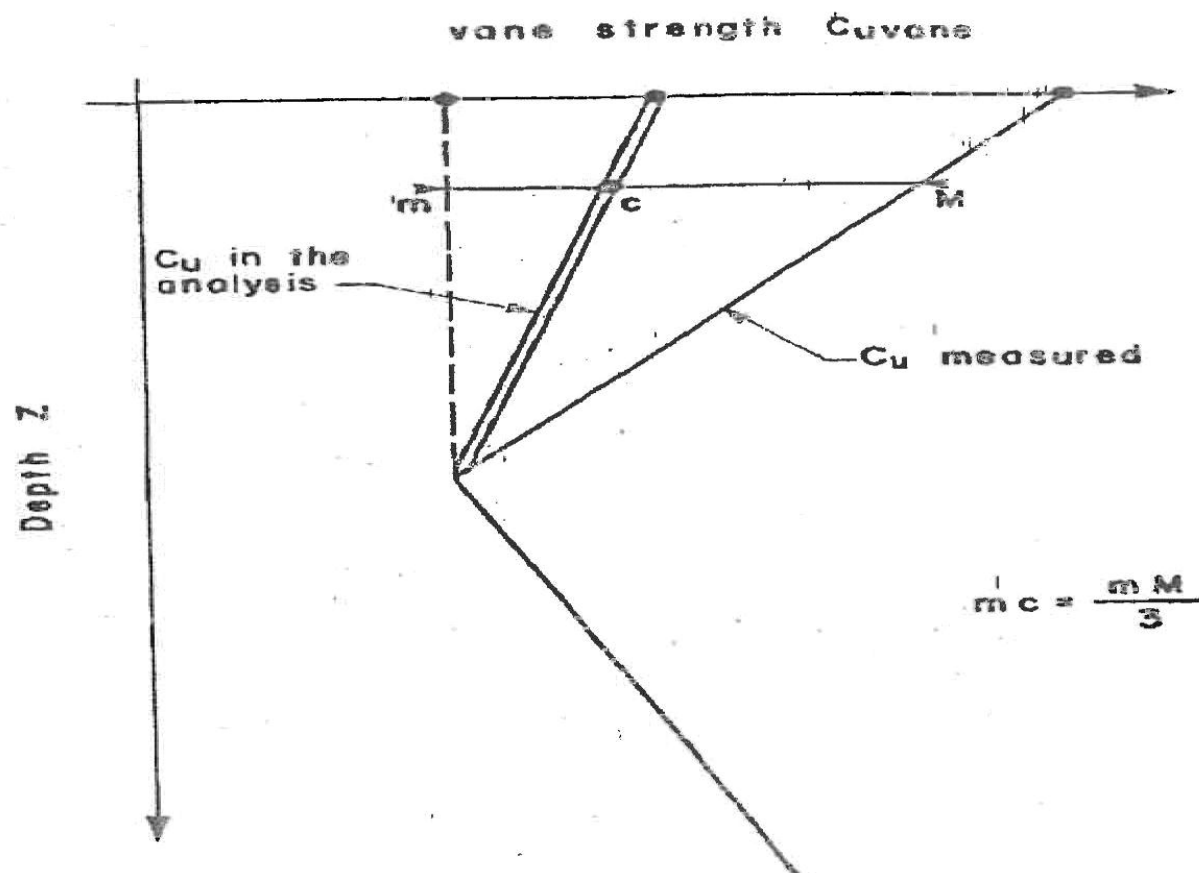
FIG. 4 . Strength profile in the weathered crust.
(REF 14)

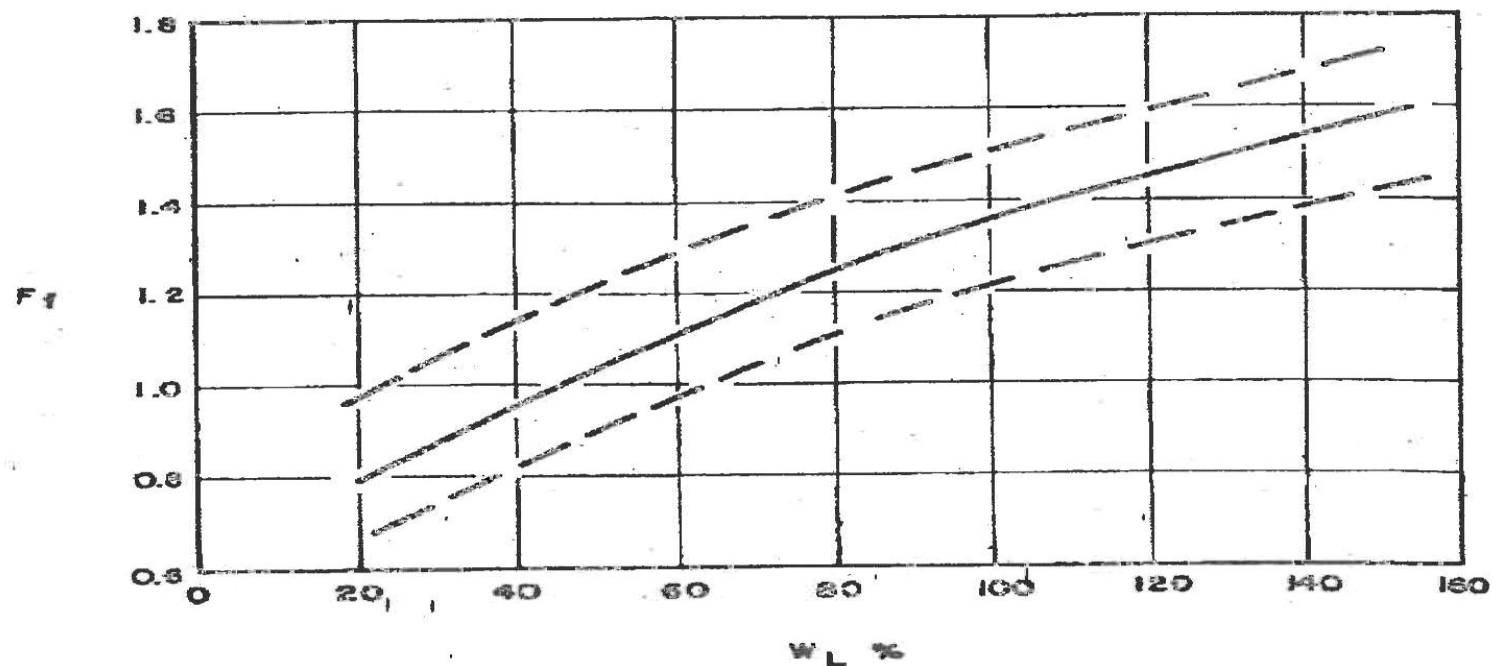
FIG. 5. Proposed correction of the factor of safety computed from the vane strength (Ref 14).

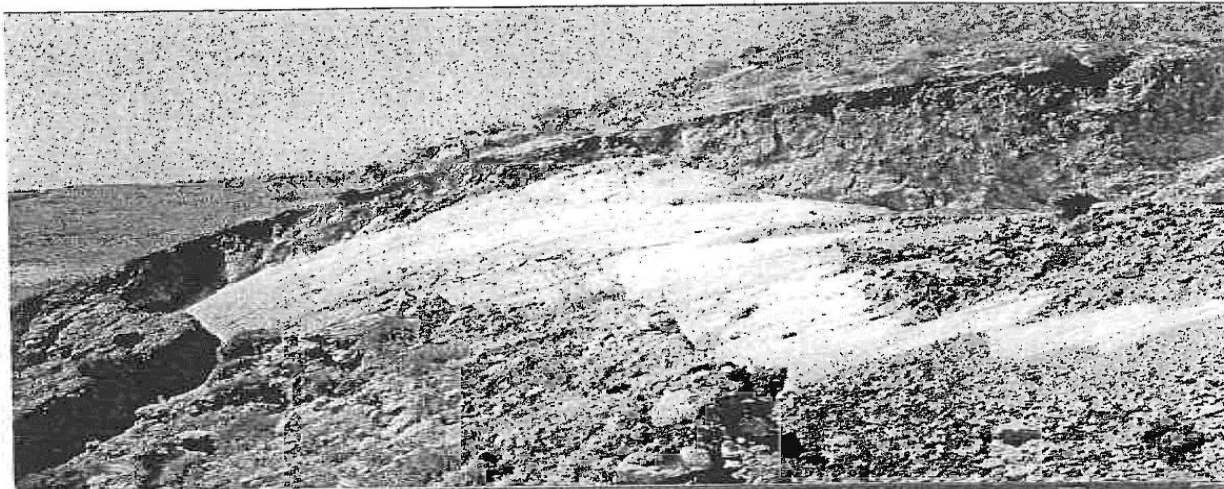
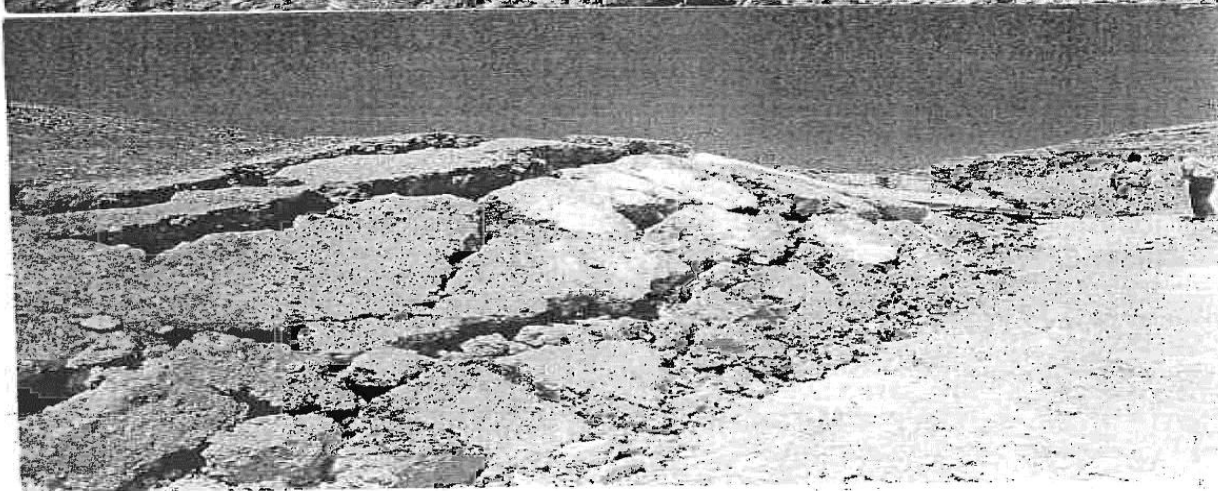
Figure 8. July 10, 1995 landslide at WESTP project, (a) the 2 to 8m deep scarp with the sliding surface along the moderately dipping stratum of plastic clayey marl underlying the jointed weathered limestone, (b) the heave at the toe of the rotational slide in the plastic clayey marl.

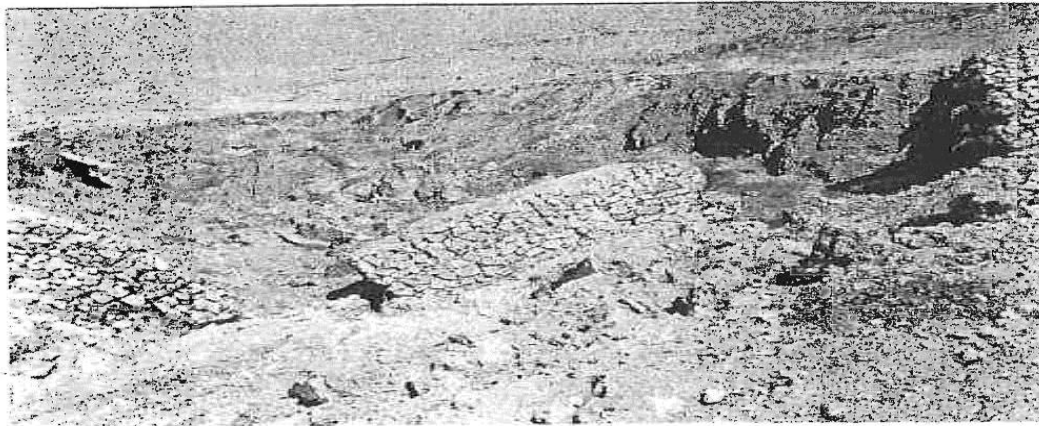
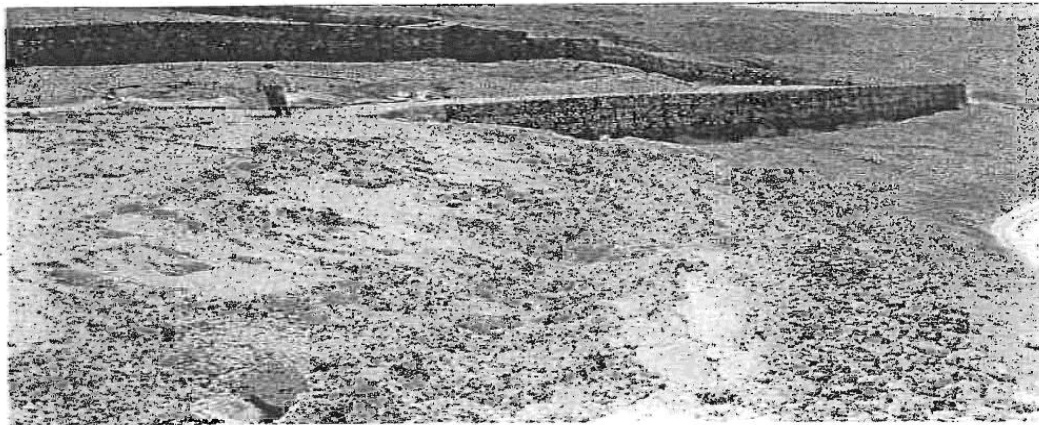
Figure 9. February 23, 1997 landslide at WESTP project, (a) the dislocation and separation of the gabion wall in the middle of the slide, (b) the standing undisturbed gabion adjacent to the displaced one with a dislocation of about 6 to 9m at the toe of the slide.

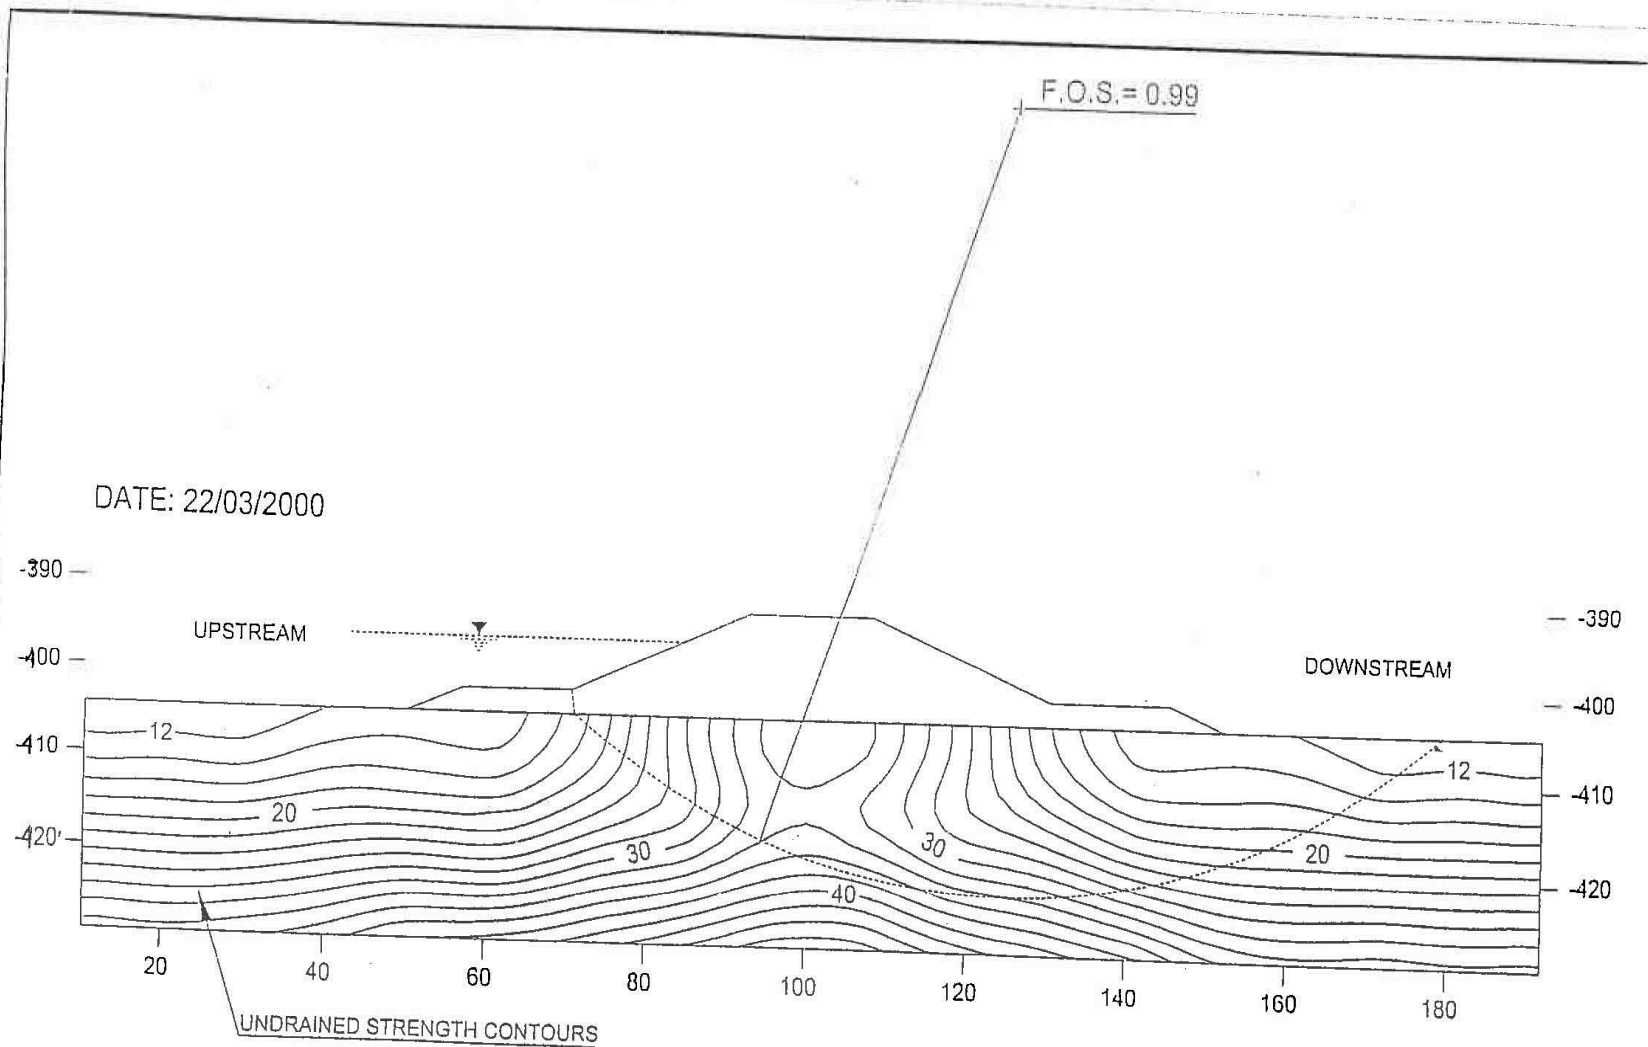
Fig. 12 END OF IMPOUNDMENT CRITICAL SLIP SURFACE (Ref. 2)

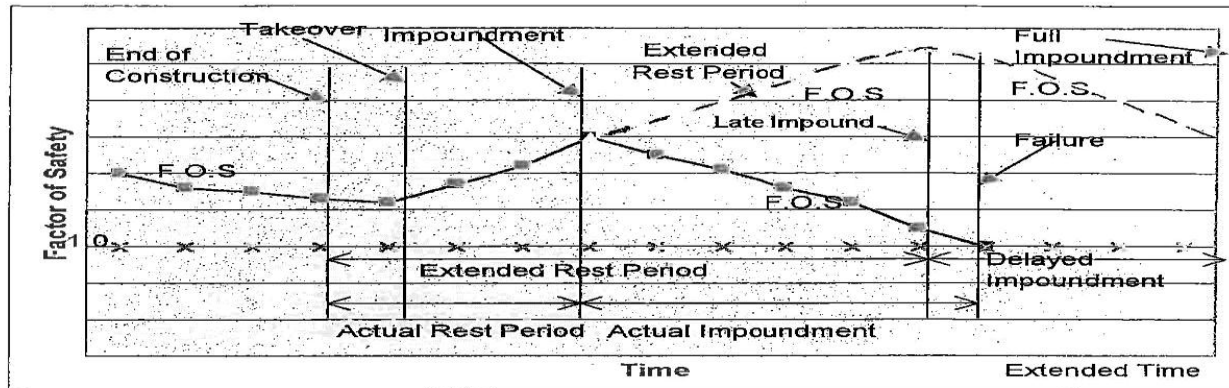
Fig. 13

An illustrative sketch that shows how the F.O.S. started to increase during the rest period and started to drop during impoundment until it reached 1.0 at time of failure. It also shows how an extended rest period and slower impoundment could have saved the dike with F.O.S. higher than 1.0 at full impoundment.
